Mine Name: Unpermitted

Permit number: M/035/024

Inspection Report Minerals Regulatory Program

Report Date: March 31, 2005

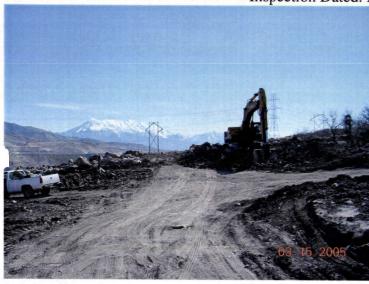
The trackhoe was digging in a hole about 5-10 feet deep and was excavating large rocks which are used in the operator's landscaping business (Photo 1). Other disturbances in the area are shown in Photos 2-4. These disturbances are basically on the surface and do not include excavations. Much (though not all) of the vegetation has been removed in these areas, and there are a lot of rocks on the surface. The soil has been disturbed and may have been mixed with subsoil materials. I think it unlikely that the soil has been damaged much, but this is possible.

Photo 1. The trackhoe that was digging at the time of the inspection.

- 1. Because there is so much disturbance in the area, and because it is impossible to distinguish between the areas for which the operator is and is not responsible, the area included in the NOI needs to be marked with T-posts or something similar.
- 2. Any reclamation required by the Stop Work Conference needs to be done as quickly as possible. The normal time to reclaim is in the fall; seeding in the spring can work if done early enough and if there is consistent adequate precipitation.

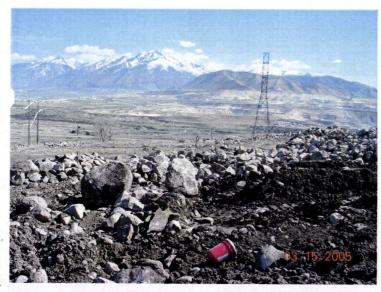
Photo 2. View of some of the disturbance in the area.

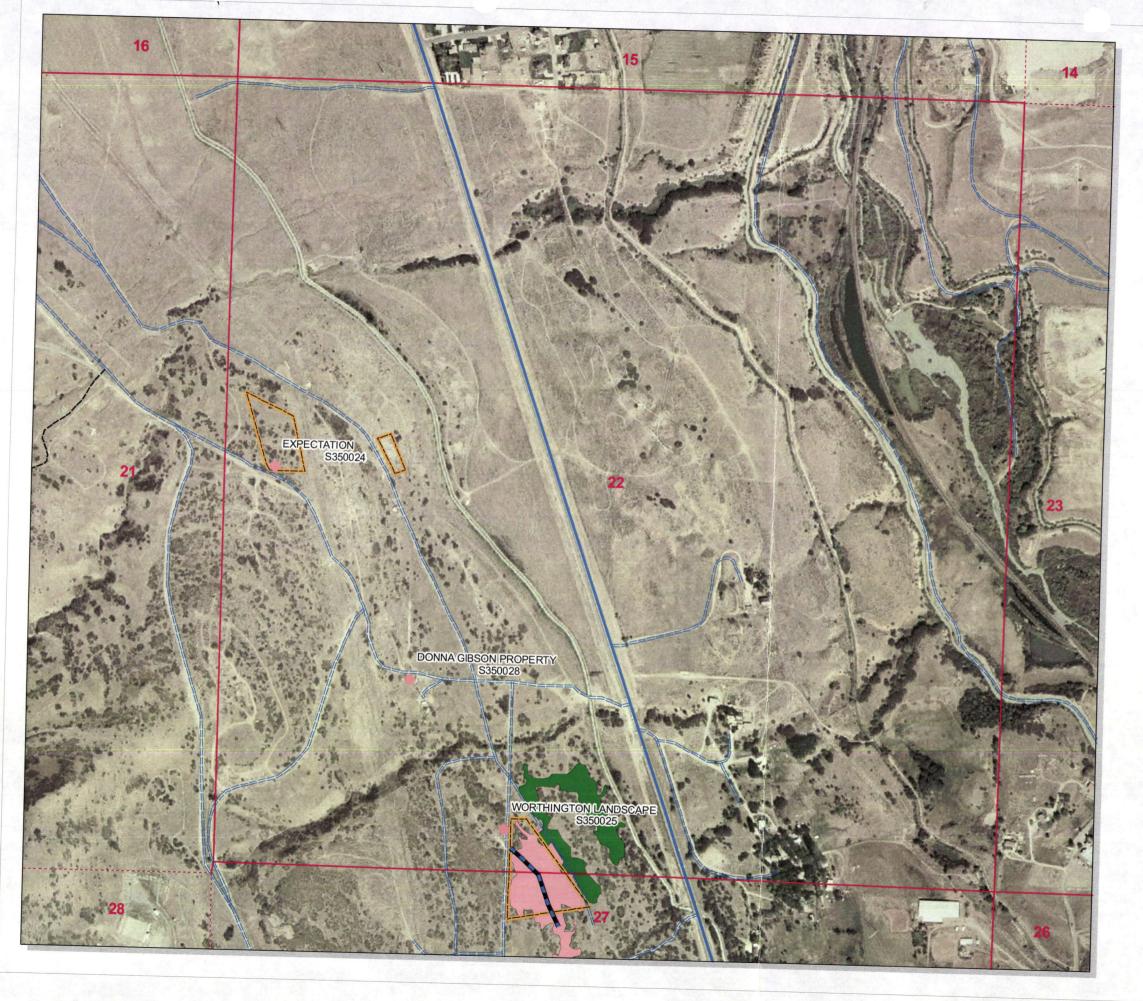
Mine Number: S350024 Mine Name: Expectation Township 04 S Range 01 W Section 22 SLBM

Acres Disturbed	3.2
Acres Regraded	0
Acres Seeded	0
Road Acres Disturbed	0

Total Acres Distrubed 3.2
